SWIFT COUNTY COURTHOUSE

Benson, Minnesota
Exterior Envelope Assessment

Re: County Courthouse Exterior Envelope Condition Assessment
CDG Project 13061.00

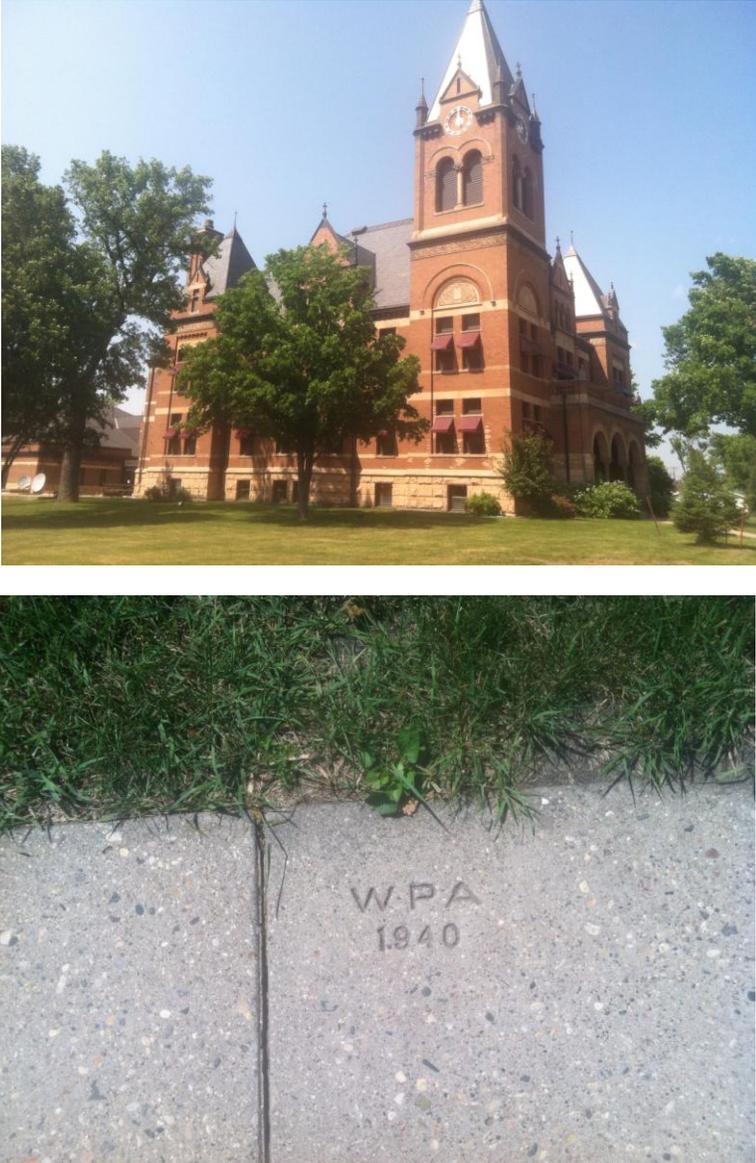
OBSERVATIONS	REFERENCE PHOTO
<p>View of the south and east walls of the courthouse. The building is in excellent shape and has been very well maintained. The building has been repointed at least once, and original windows were replaced with clad wood sash single hung units. Slate roof is recent.</p> <p>Note panel infill at former transom windows (above canopies).</p> <p>Significant historic construction from several eras is present and in good condition.</p>

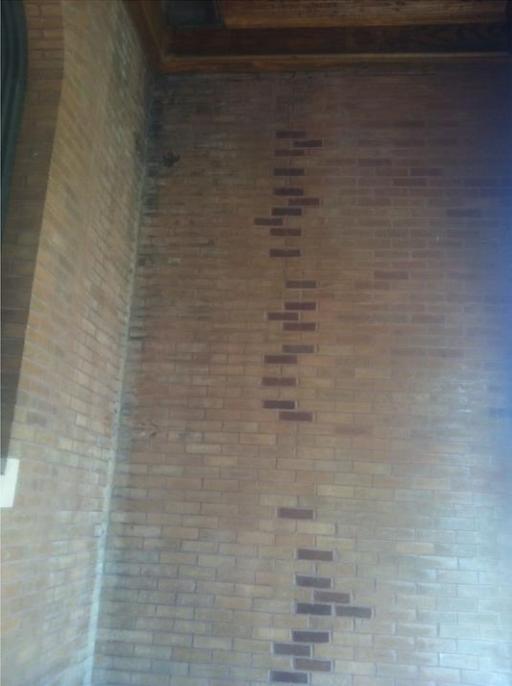
OBSERVATIONS	REFERENCE PHOTO
<p>Previous repair work has been effective, though not always discrete.</p>

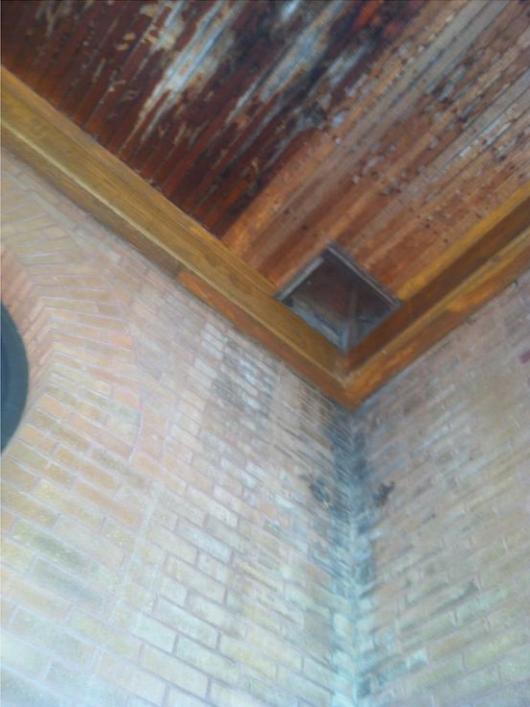
<p>The leaking roof of the porch is a serious concern. The original wood ceiling and brick walls are deteriorating due to the volume of water passing through the roof assembly.</p>

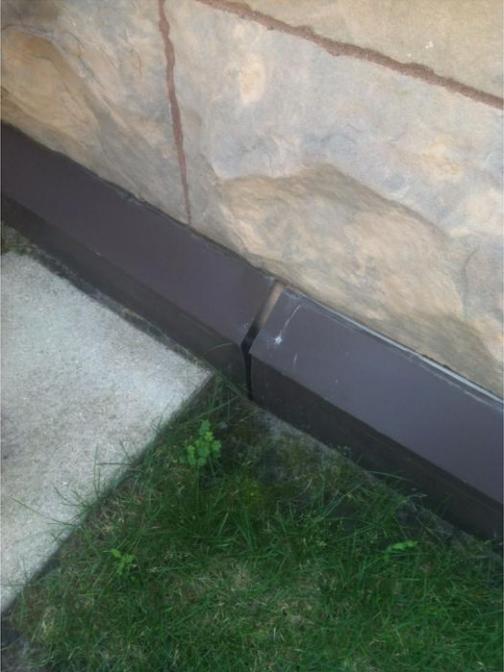
OBSERVATIONS	REFERENCE PHOTO
<p>The perimeter sill flashing, covering the stone base of the wall, is in need of isolated patching and replacement of joint covers.</p>

We recommend repairing the existing masonry walls, where necessary. Most immediately, the water-table course should be repointed along with overall spot repointing as required. Penetrations at pipes and conduits should be sealed, and the metal base flashing should be repaired as necessary.

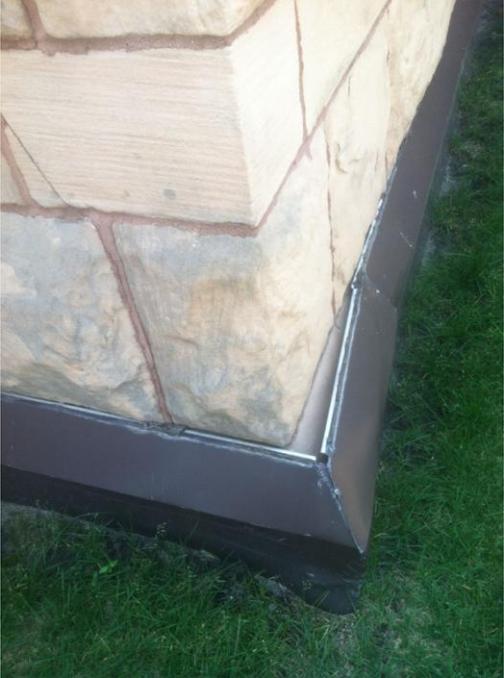
<p>Sill Flashing has been displaced due to lawnmower action, and should be replaced.</p>

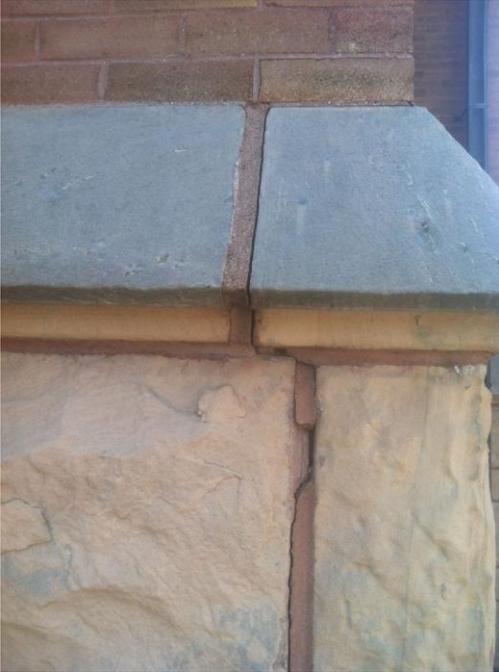
OBSERVATIONS	REFERENCE PHOTO
<p>The water-table stone coursing and the rusticated base stone are in need of repointing with appropriate mortar.</p>

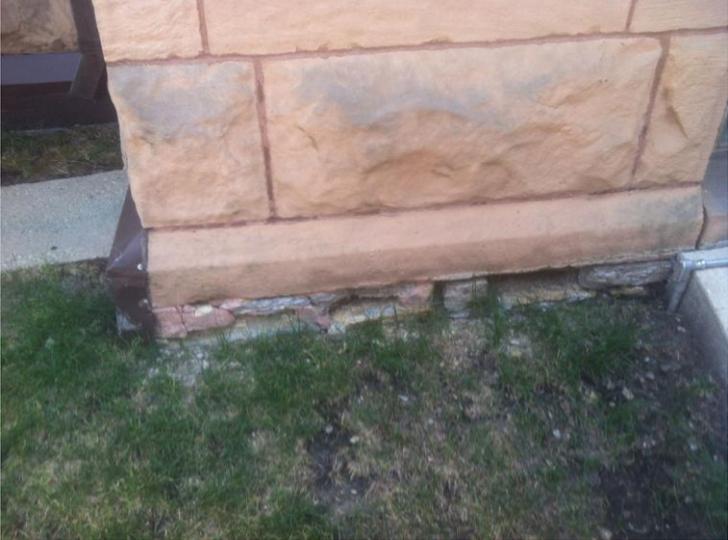
A close-up photograph of a stone wall. The top portion shows a course of smooth, light-colored stone blocks with visible mortar joints. Below this is a course of larger, more textured, light-colored stone blocks. The mortar joints between these blocks are dark and appear to be in poor condition, with some crumbling and missing mortar, indicating a need for repointing.
<p>Along the west elevation, where the base course is not covered by flashing, the limestone foundation has deteriorated. This condition should be repaired..</p>

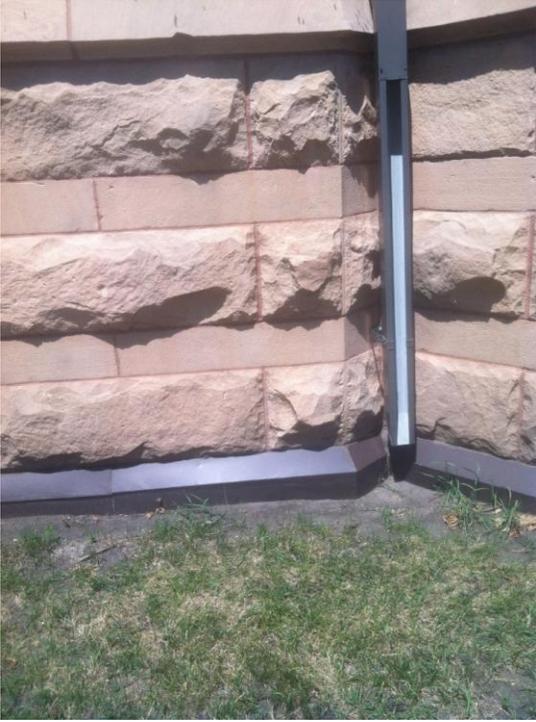
OBSERVATIONS	REFERENCE PHOTO
<p>Many rain downspouts do not have kickers / diverters to move the water away from the building. Scouring is visible at base of wall where water is percolating into soil immediately adjacent to walls, potentially entering the building,</p>

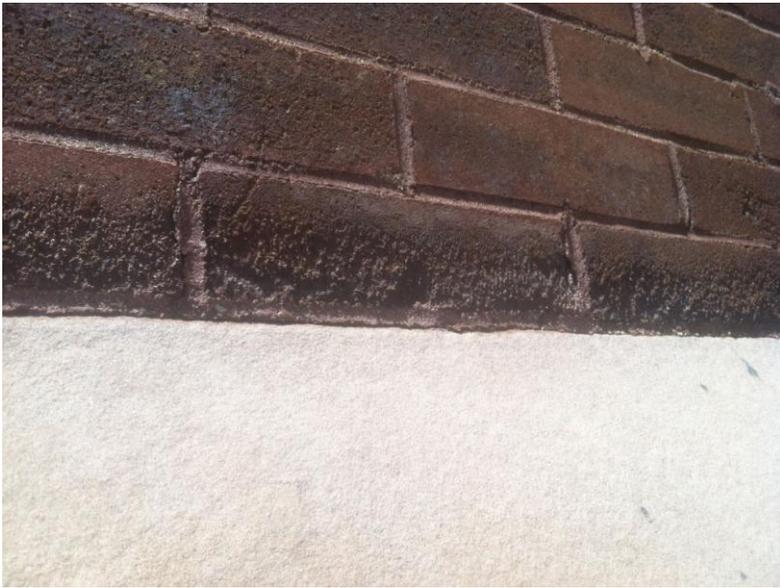
<p>Normal micro-erosion of brick was observed in some locations at top of belt course, where water vapor exits the wall assembly. This is normal for a 100+ year old building, and is not a concern unless it starts to accelerate.</p>

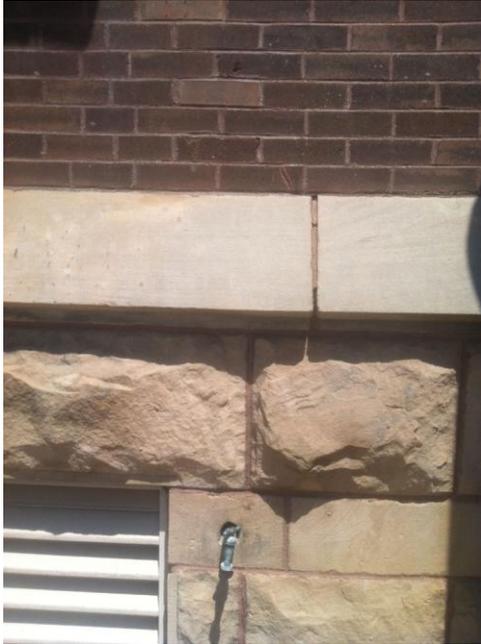
OBSERVATIONS	REFERENCE PHOTO
<p>Note open penetration at hose bib. This opening should be sealed. Open joints at water-table should be repointed.</p>

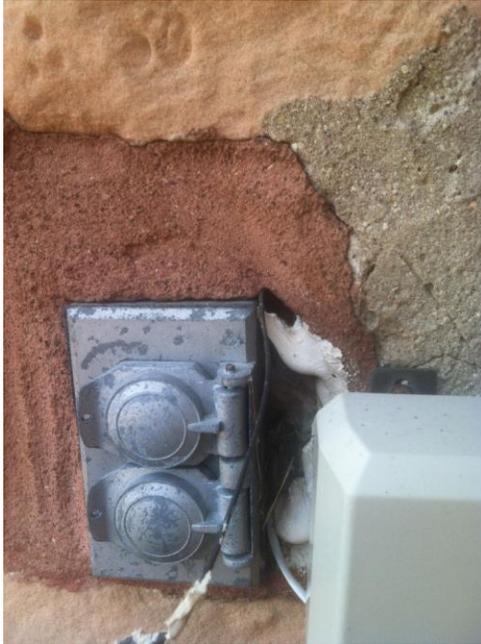
<p>Openings through wall at outlet boxes and conduits should be resealed.</p>

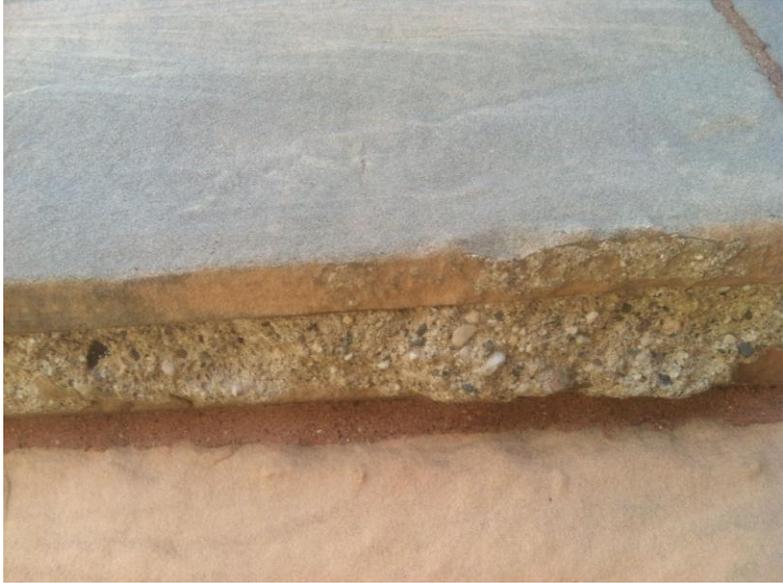
OBSERVATIONS	REFERENCE PHOTO
<p>Previous repair work under lip of water-table was well done, but is near life expectancy and should be redone at time of water-table repointing.</p>

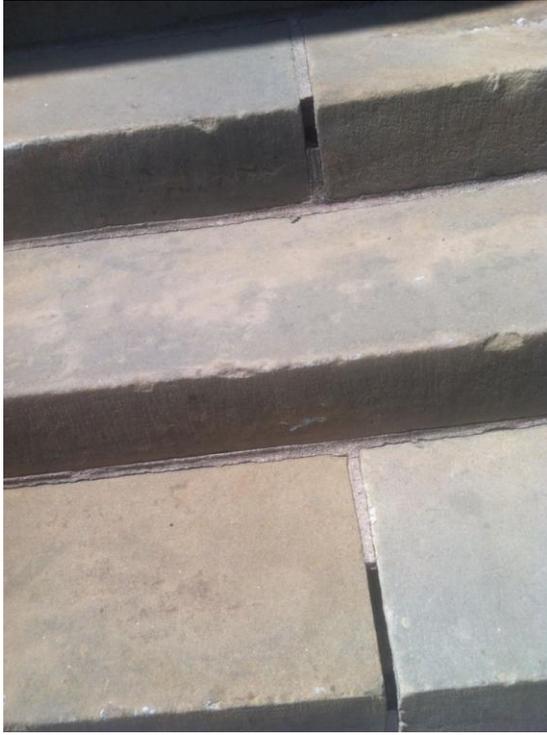
<p>Stone steps should be reset and repointed. Step stone slabs are in excellent condition.</p>

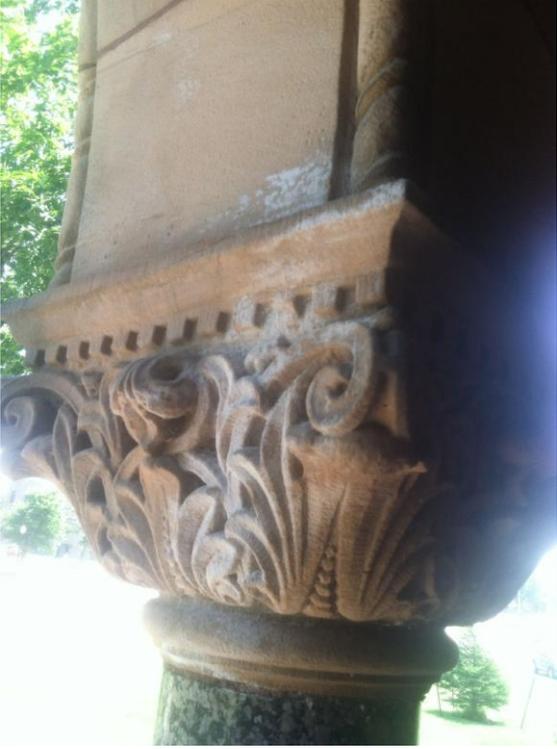
OBSERVATIONS	REFERENCE PHOTO
<p>Efflorescence on porch columns is due to water flow from roof leaks on porch. This should be cleaned off after roof repairs.</p>

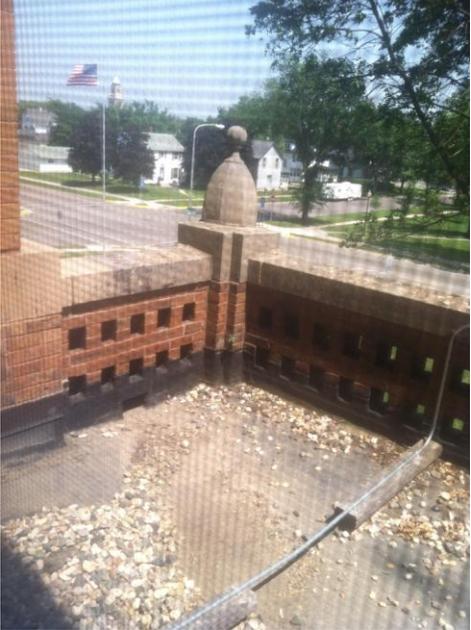
<p>View of porch roof, showing significant displacement of ballast due to forceful water flow. Roof is beyond life expectancy and leaking in several places.</p>

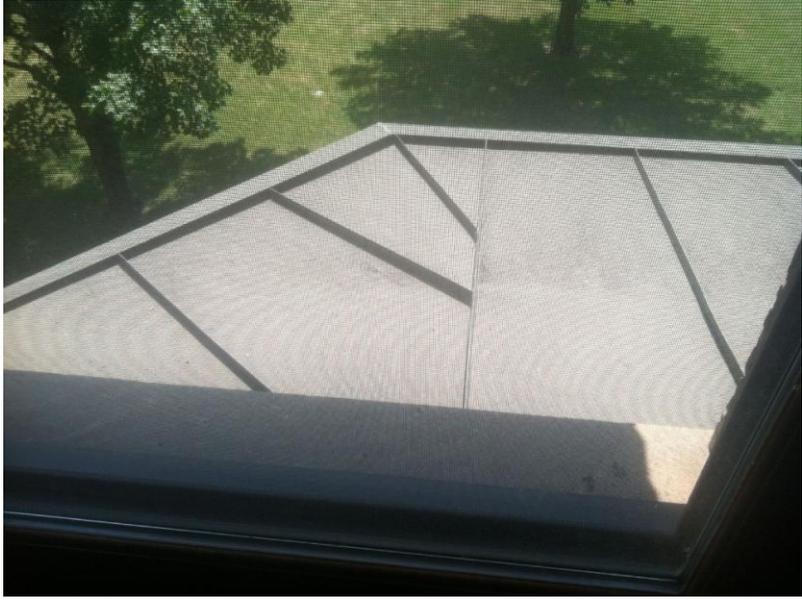
OBSERVATIONS	REFERENCE PHOTO
<p>Roofs of bays at County Board room and Registrar's office are metal of recent vintage, and in excellent condition.</p>

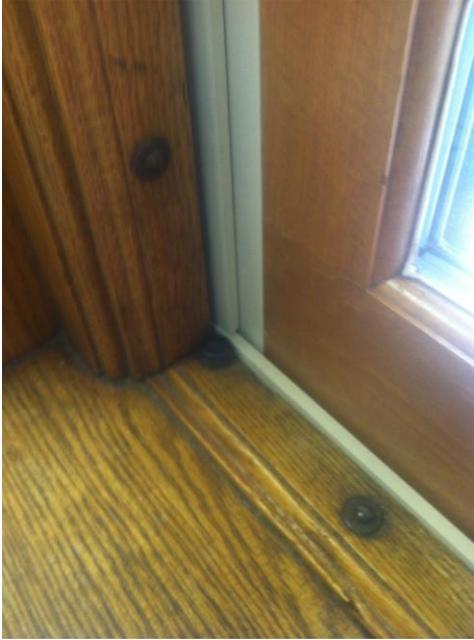
OBSERVATIONS	REFERENCE PHOTO
<p>Replacement window units were installed with minimal disruption to historic wood trim. However, gaps between new windows and original construction are very common.</p>

The windows should be repaired and retrofitted with sealant and weatherstripping. Gaps at sashes should be minimized. Windows that will not be operated (e.g. courtrooms) can be more securely sealed. Additional sealing and repair should be done at the original window casings, which in many cases have worked loose and now allow additional drafts.

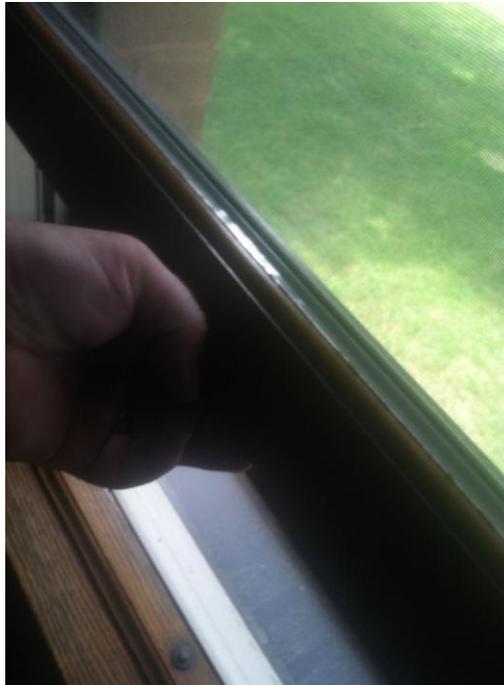
Many sashes do not hold position when opened, and require blocking or other materials to be used. Staff stated a general preference for operable windows, though a relatively low frequency of use.

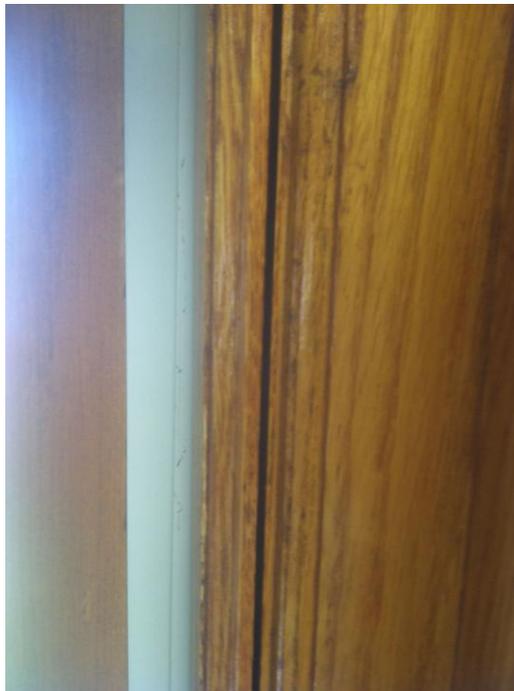
Gaps at existing assemblies are common. Many stops are loose and can be finger-tightened.

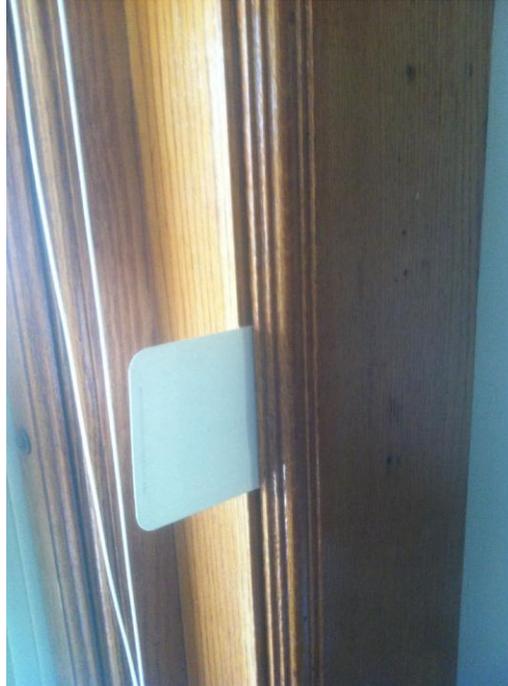
Coverstock paper can be inserted into gaps in most window assemblies.

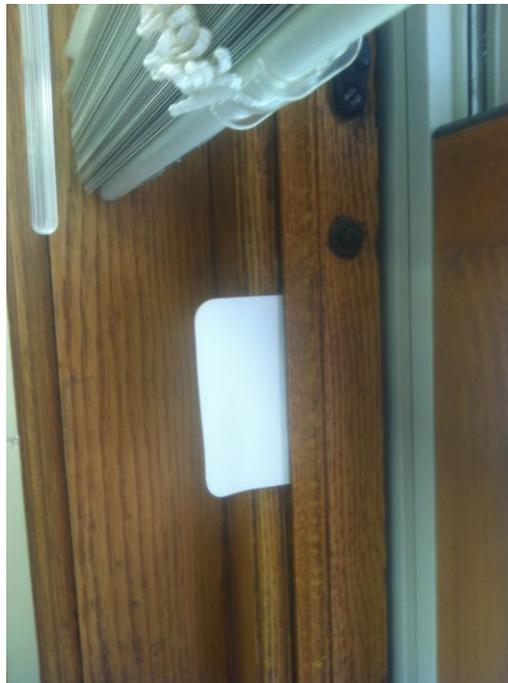
In some cases the Coverstock can be inserted entirely through the assembly to the outside.

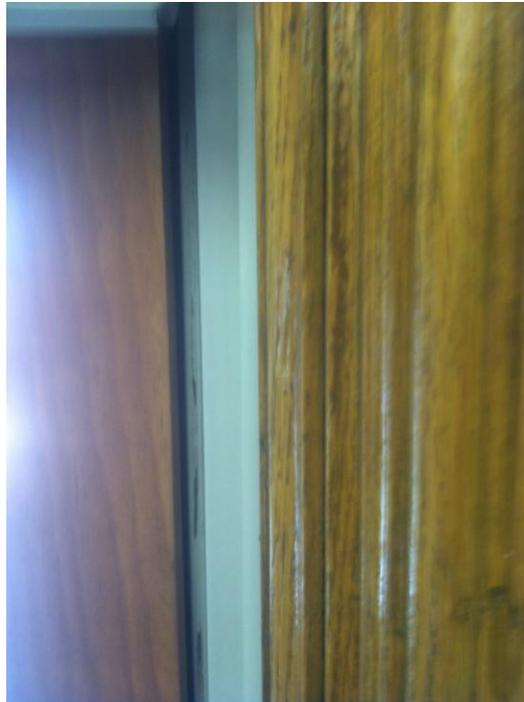
Gaps at sash / track / frames are typical.

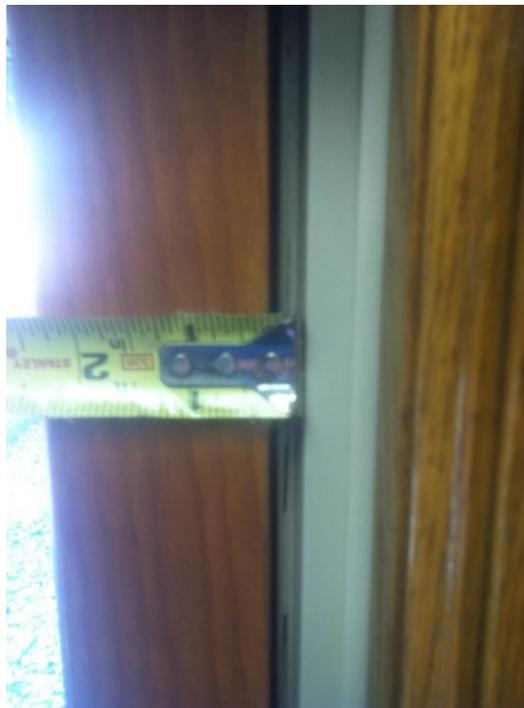
Gaps at sashes often reach one quarter inch.

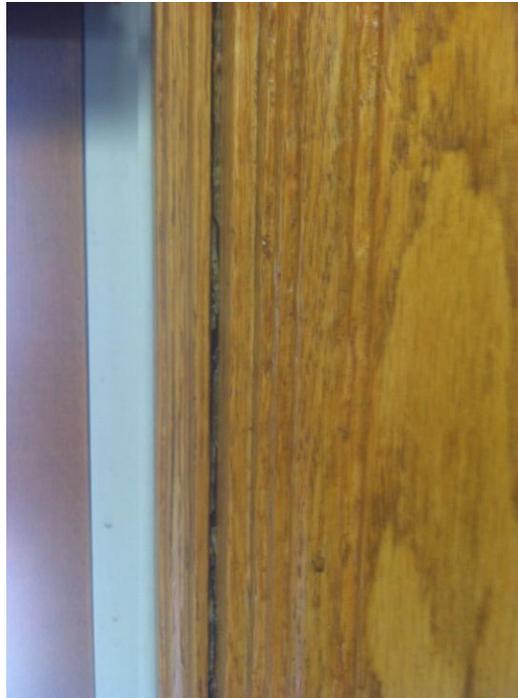
Typical loose assembly
– historic woodwork in
need of re-setting.

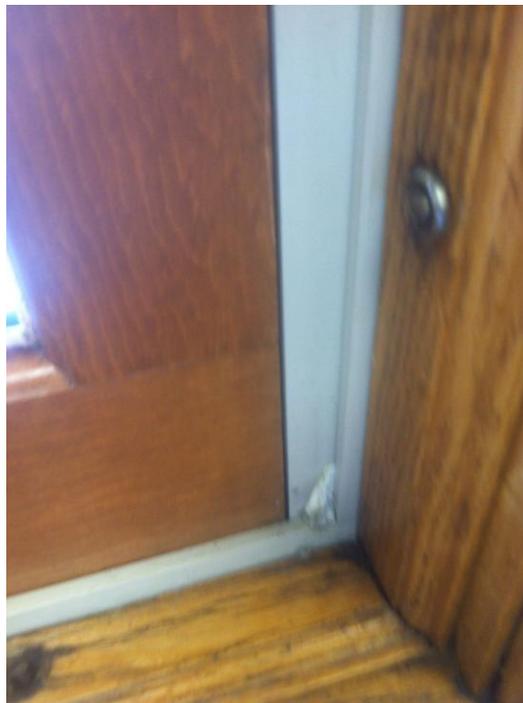
In some instances staff
members have
attempted to seal
windows with paper or
other materials.

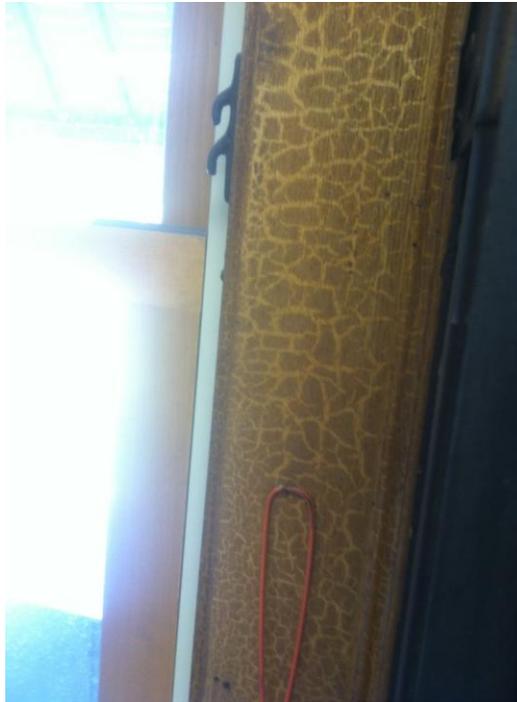
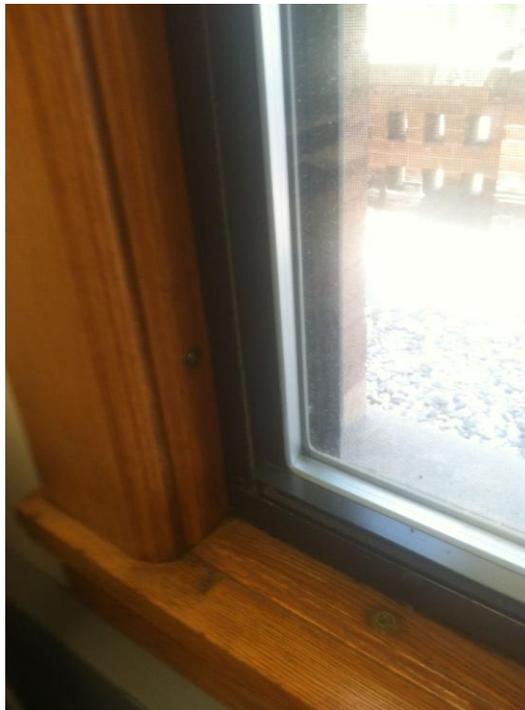
Windows in vaults have original steel shutters in place. Shutters are still routinely operated. Where infiltration at windows is significant when shutters are closed, temperature swings and moisture have caused deterioration of finish on historic millwork.

Some locations on the second floor have aluminum replacement windows that do not match typical wood sash units. These units appeared to be in good condition. Some units have become more difficult to operate but are otherwise intact.

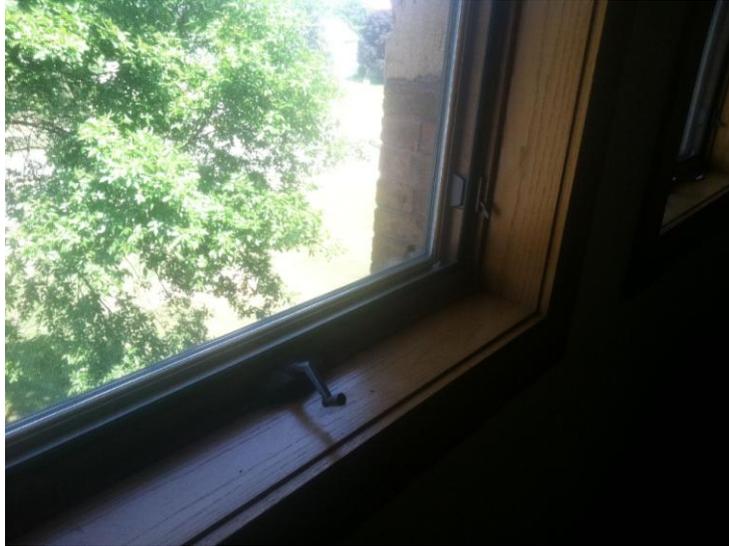
Replacement windows on third floor at main stairway are modern awning-style units. Exterior patching indicates significant reconfiguration was done to windows in this area at some time in the past. These windows are in excellent condition.

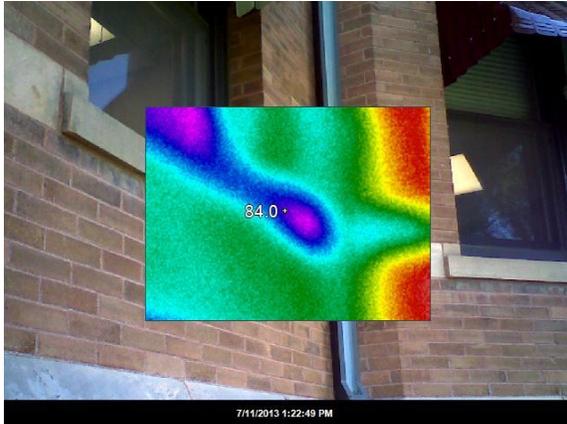
Wall at NE corner of Registrar's office.

Note cool spot trailing away from first floor window into wall mass, indicating exfiltration.

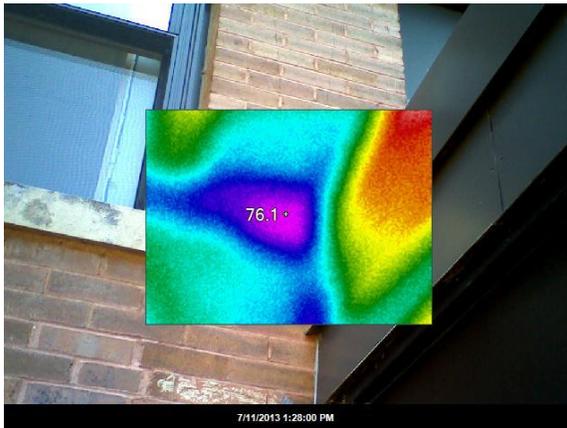
Wall adjacent to County Board Room.

Detail view of cold spot in wall adjacent to first floor window.

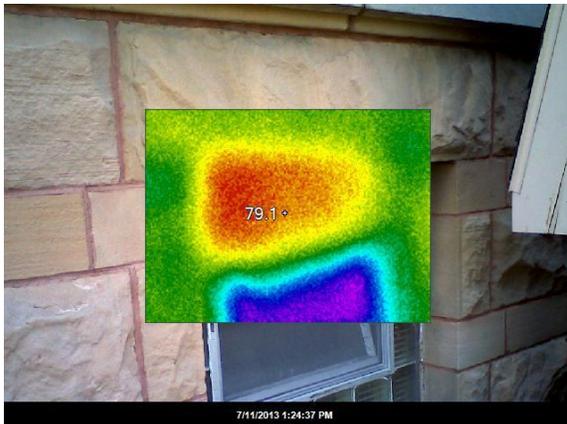
Lower Level window, north elevation.

Note "hot" plenum showing at transom panel location.

The plenum spaces created by the addition of dropped ceilings exhibited a significant temperature differential from the spaces adjacent. As these are unconditioned spaces, this is not surprising. Consideration should be given to better venting or conditioning these spaces to the interior rooms, and installing insulation at the transom panels, to improve the thermal inertia of the building as a whole.

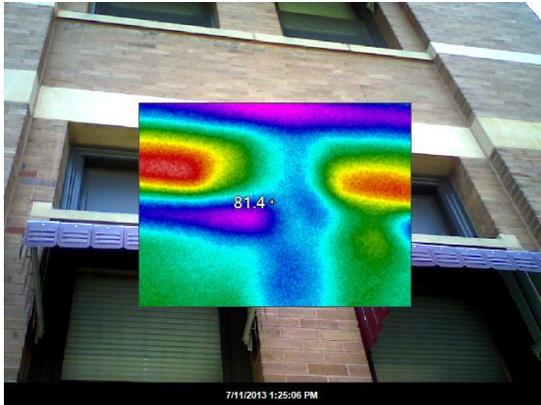
Typical window assembly, north elevation.

Note "hot" plenum showing at transom panels against relative coolness of sandstone.

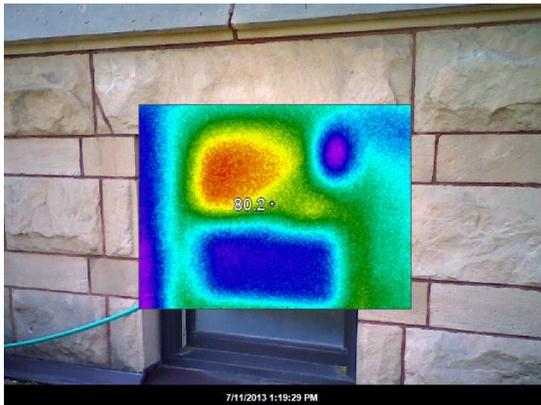
Northeast corner, Lower Level Men's Room window:

Note "hot" plenum, and cold air leaving the building at unsealed hose bib penetration through window sash.

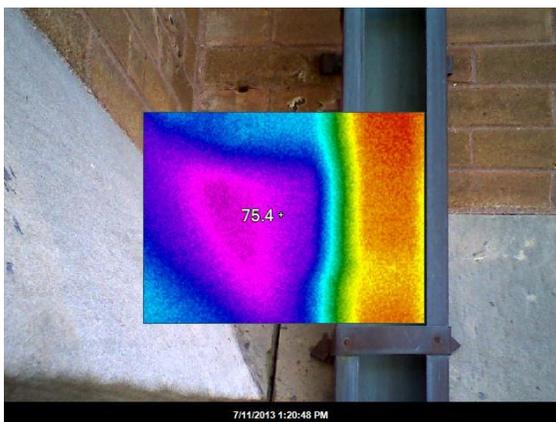
Northwest corner.

Cold area indicating likely air / water infiltration at penetrations.

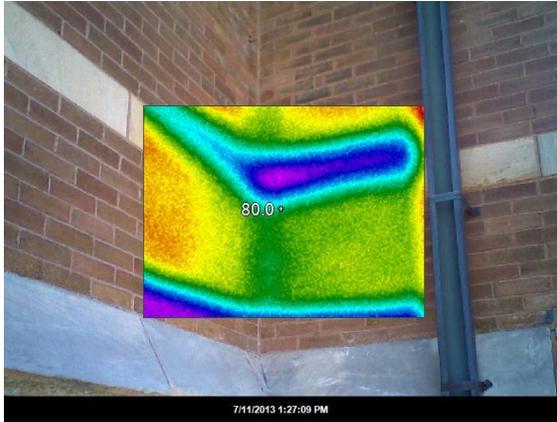
Northwest corner.

Note cool area of sandstone caused by moisture migration out of wall.

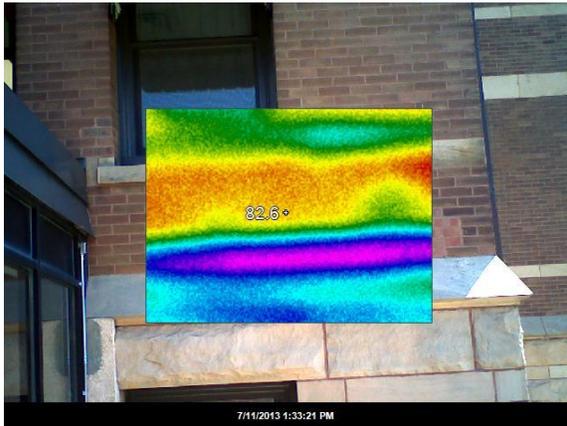
Southwest corner.

Typical wall assembly showing cool belt course.

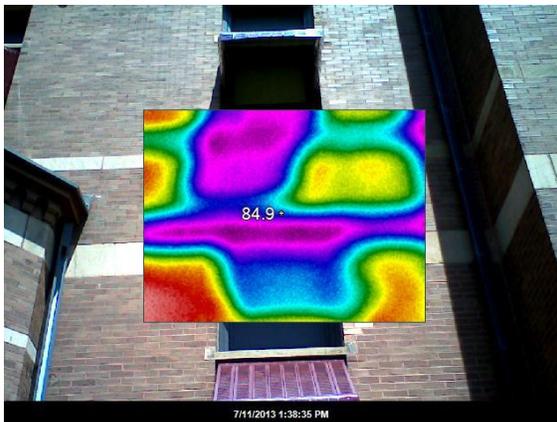
Typical wall assembly (South elevation).

Note cool window and cool belt course.

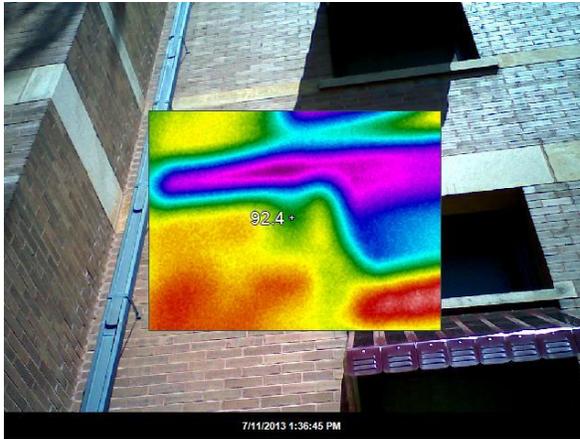
Typical wall assembly (South elevation).
Note cool window and cool belt course.

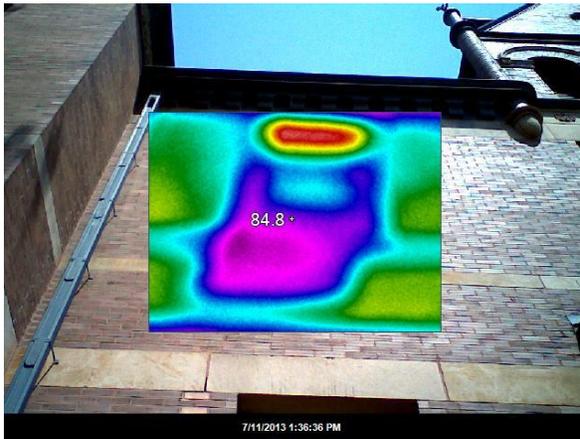
Typical wall assembly (South elevation).
Note cool window with hot transom panel.

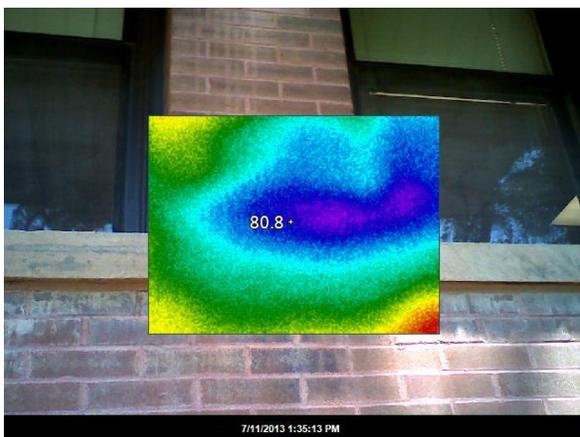
Typical window (South elevation).
Note cold spot associated with exfiltration of cold air.
